Analysis of Ice Formation and Winter Flooding on Flat Creek, Wyoming, Between November 2018 and March 2019

Edward Kempema, Ph.D.
Presented to the
Flat Creek Water Improvement District
April 12, 2020

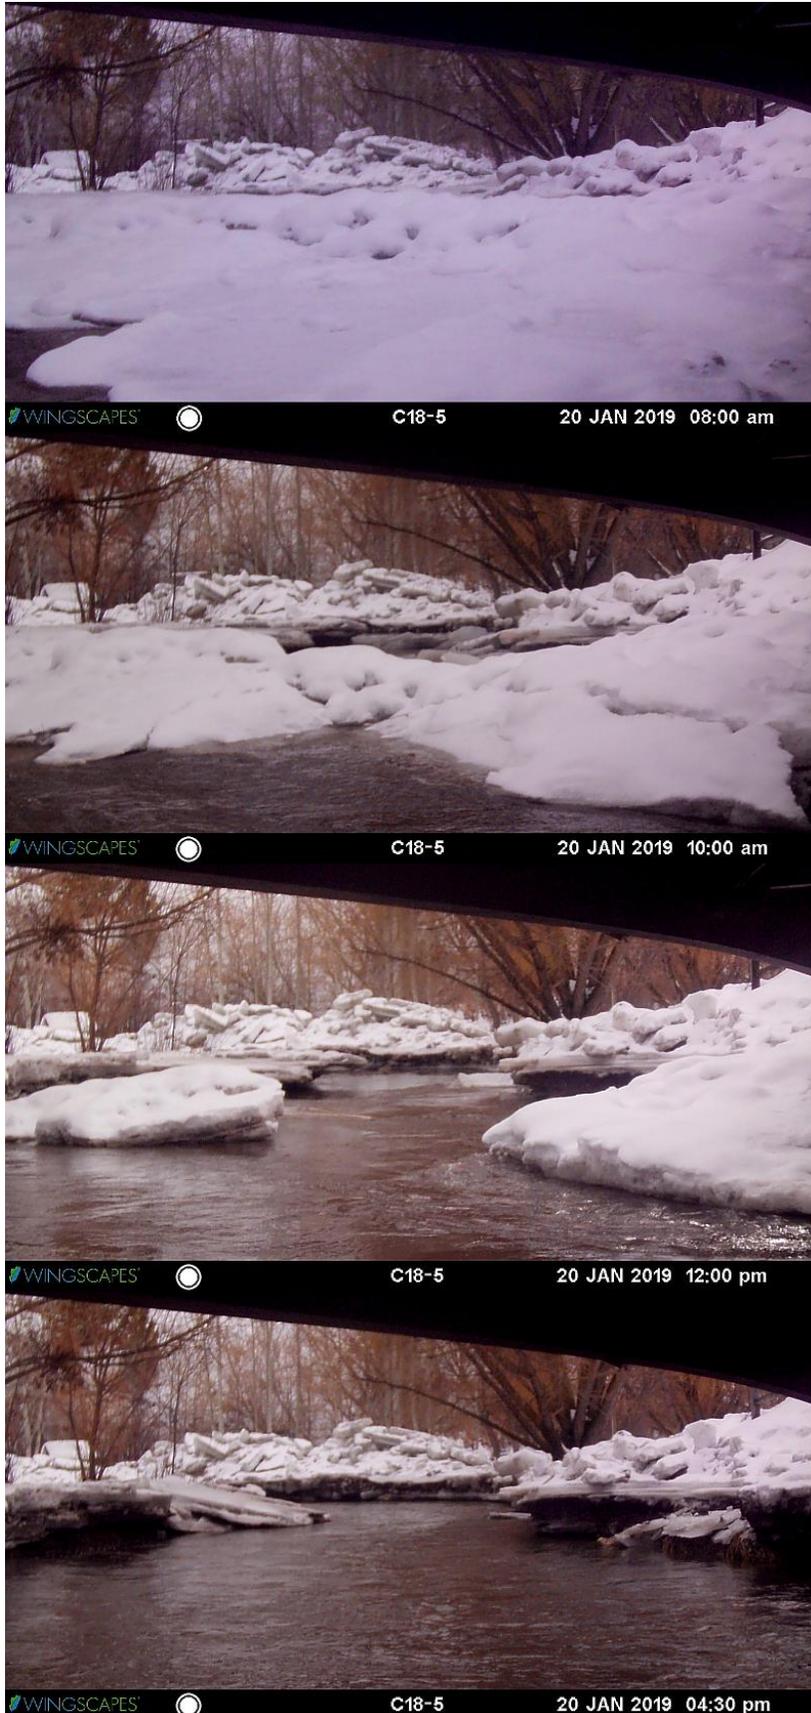
Figure 3. These four panels taken from the time-series camera located at the Crabtree Lane bike path bridge in Garaman Park (station C18.5) illustrate the dynamic nature of ice conditions along Flat Creek. Warming air temperatures on January 19 and 20 precipitated a complete collapse of the anchor ice dam just upstream of the bike bridge as warm water from the Elk Refuge flowed downstream. Water level behind the dam dropped about 1 m (3.3 feet). This event cleared all the ice from the Flat Creek channel in a matter of hours. The jumbled ice rubble in the background was excavated from the Creek on January 15, 2020. The excavator could not reach the ice dam.

region, multi-day anchor ice cycles occurred (MDCs, described in Kempema and Ettema, 2018) and significantly raise the water level. These MDCs and their associated large water level increases were especially prevalent from early December through mid-January and raised water levels over 1 m (3.3 feet) at some downstream locations on the Creek (Figure 2). This pattern has been observed during previous winters. Similar magnitude cold fronts later in the winter do not have the same effect on water levels, as noted by creek-side residents since before the beginning of this study in 2015. This is attributed to the effect of increased solar radiation arriving at the stream as the year progresses due to increasing sun angles and longer days. The increased sun angle increases insolation at the Creek as it rises above Snow King Mountain for longer periods. Figure 2 illustrates the delicate thermal balance that controls the attachment of anchor ice, as either a carpet or as discreet ice weirs or ice dams, to the bed. For example, increased average air temperatures on December 18 and January 20 resulted in complete removal or melting of the ice structures in the Creek channel, leading to reduced water levels along the entire study reach (Figure 3). This complete removal was accompanied by the 0°C isotherm migrating downstream in the “zipper effect” described by Kempema and Ettema (2018) and was confirmed by the time-lapse photo series, which show ice-free channels after these events, although there is considerable ice still present as overbank accumulations above the stream level (Figure 3).

I had a telephone conversation with Mr. Carlin Gerard of the Teton Conservation District on April 1, 2019. Mr. Gerard reported that it was a very bad year for ice in the Creek. Mr. Gerard was out on January 14, 2019, when excavators removed ice from the streambed for “about ½ mile bellow Klyn's”. Mr. Gerard was careful to point out that this was an estimate of the distance, but that large amounts of ice that had completely choked the channel had to be removed by an excavator. This made an impressive pile on the riverbank (e.g Figure 3). The excavators started removing ice from upstream at

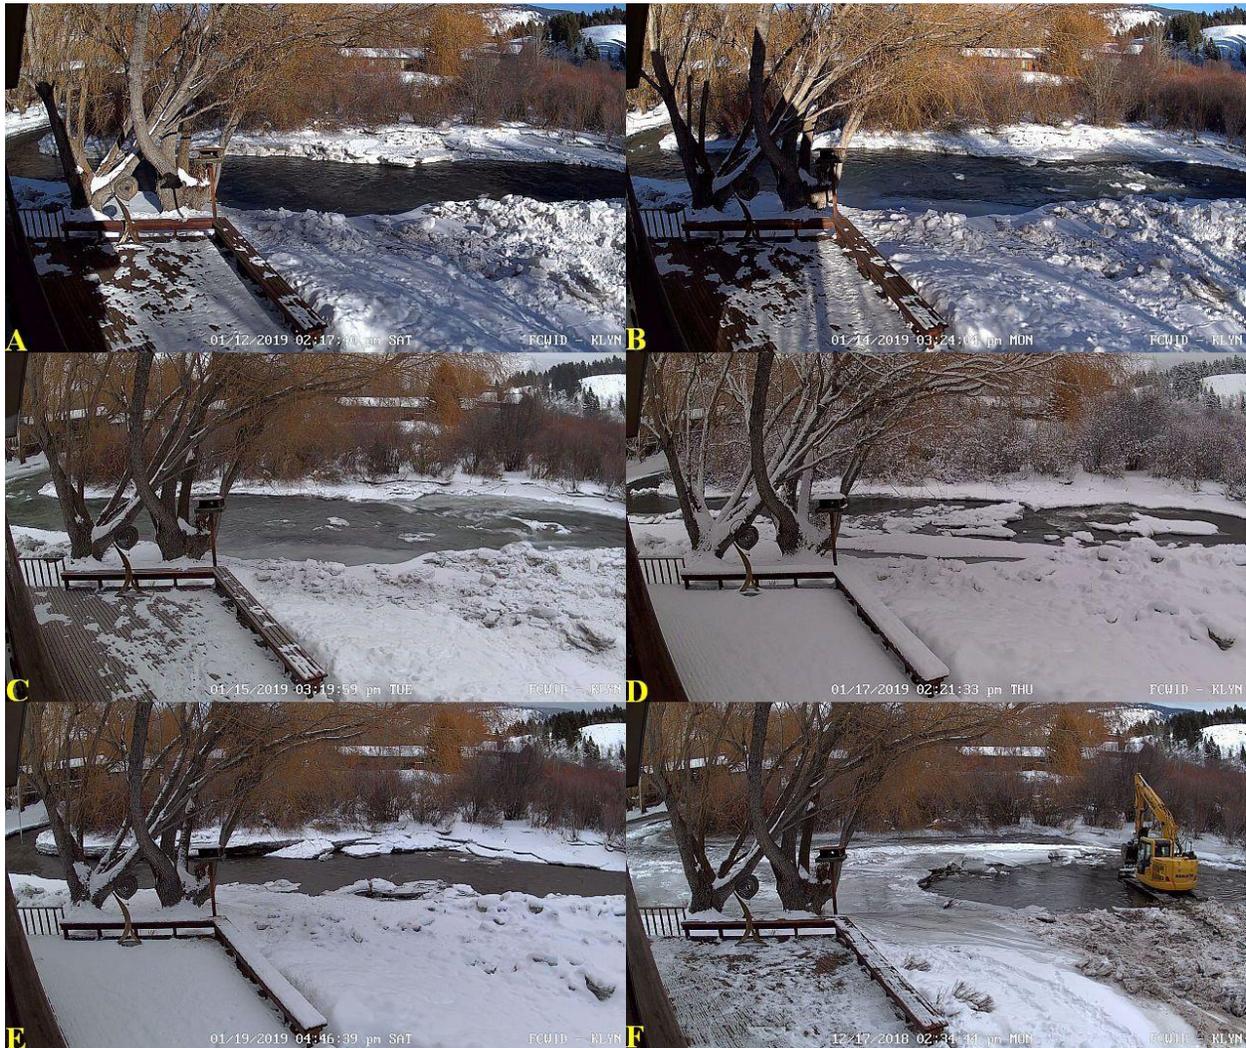
Figure 4. A to E: Progression of channel choking as anchor ice grows from the streambed upward to the water surface. A: Ice-free channel lined by border ice; B: anchor-ice growth to air-water interface and initial icing formation; C & D: icing covers more of the water surface as ice chokes channel; E: melting of channel ice. F: Excavator clears anchor ice and icing from the stream channel on 17 December 2018. The icing stratigraphy is visible in the vertical ice face upstream of the excavator. Flow is left to right.

Figure 5 is an example use the Reolink system to monitor ice evolution and water level increases in the Creek by recording development and decay of a multiday anchor ice cycle. Multi-day anchor ice cycles follow a very regular pattern of ice development. The progression is shown by a series of images collected at Mr. Klyn’s property with the Reolink system during a multiday ice cycle spanning January 12-19, 2019 (letters refer to figure 4 images):

- A. Initial formation of an anchor-ice carpet covered essentially the entire creek bed. This carpet did not grow at a uniform rate; ice thickening was quicker on shoals, weir crests, and other obstructions to flow. Anchor-ice accumulation raised water levels.

- B. The anchor-ice carpet grew to the water surface. Accumulating anchor ice raised the local water level. Localized aufeis (icings) start growing at the air/water interface, increasing ice thickness

- C. The anchor ice carpet grew to intercept the water surface. Persistent anchor ice covering the whole creek channel emerged from the flow. At the same time, water level slowly rose and inundated low-lying areas and froze to form dense, compact aufeis deposits (icings) along the banks and in low-lying areas (see Figure 3 for exposed icings). This process is the same as described by Turcotte and Morse (2011). As the creek channel is choked, thin layers of water flowed across the icing covering the channel froze, thickening the icing upwards and increasing channel choking. As a result of water flowing across the icing, heat loss is not significantly reduced as more ice forms (Turcotte and Morse 2011).

- D. Ice continued to rise and choke the channel. More and more of the channel is covered by a form of merged ice (Tremblay et al. 2014). The merged ice consisted of a lower layer of porous anchor ice and an upper dense aufeis layer. Ice filled the entire channel. This ice will keep growing upward until one of two things (E or F) occurs:

- E. As the weather warms, the 0°C isotherm and the ice melting/release front migrate downstream. There are very few large boulders in Flat Creek, and the channel is wide, so surface ice and icings collapse into the channel as the submerged ice melts. Collapsed ice also melts, and the channel becomes essentially ice-free (this is illustrated in Figure 3). This sequence sets the stage to restart ice growth.

- F. Water level reaches a critical stage and excavators are deployed to remove ice. Strategic removal of ice lowers the water level until warm water arriving from upstream melts the remaining ice. In both of these cases, the creek is set for another round of channel choking. However, the situation is exacerbated because ice remnants fill low-lying regions along the bank and decrease channel storage capacity (Figure 3 and Figure 5 E&F).

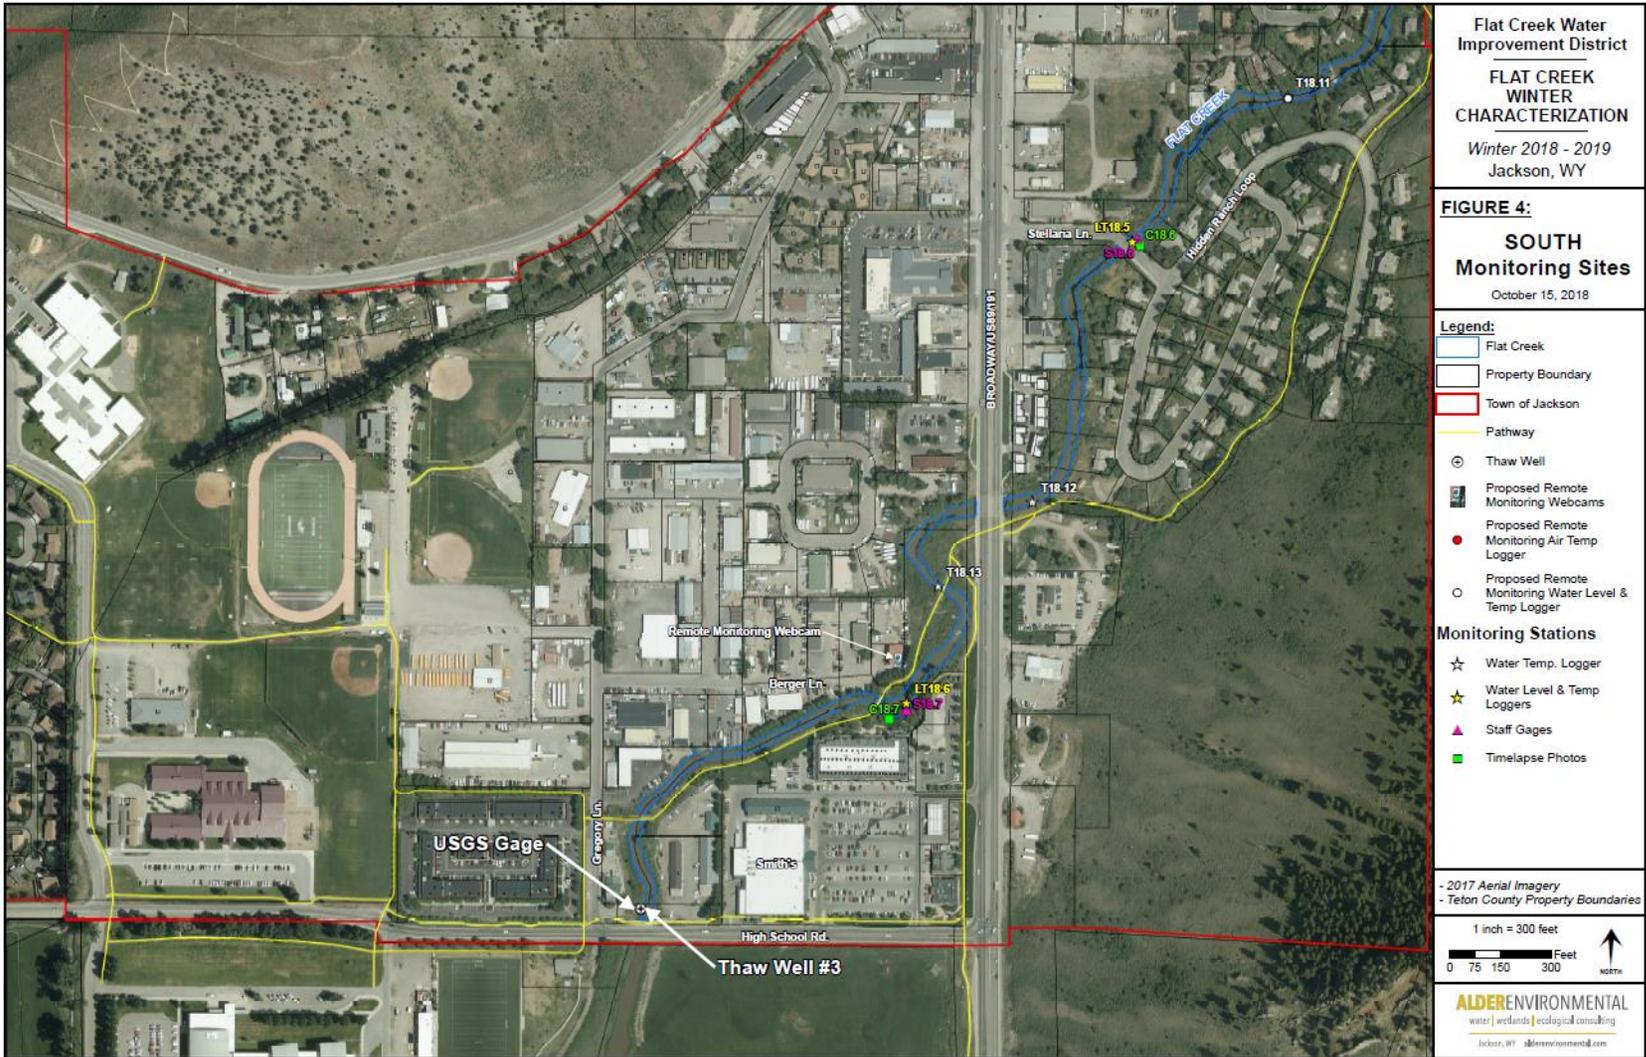
Google Earth images showing the locations of instrument packages deployed in Flat Creek during the winter of 2018-2019.
